NASA/TP—2008–000000

Lunar Dust Effects on Spacesuit Systems

Insights from the Apollo Spacesuits

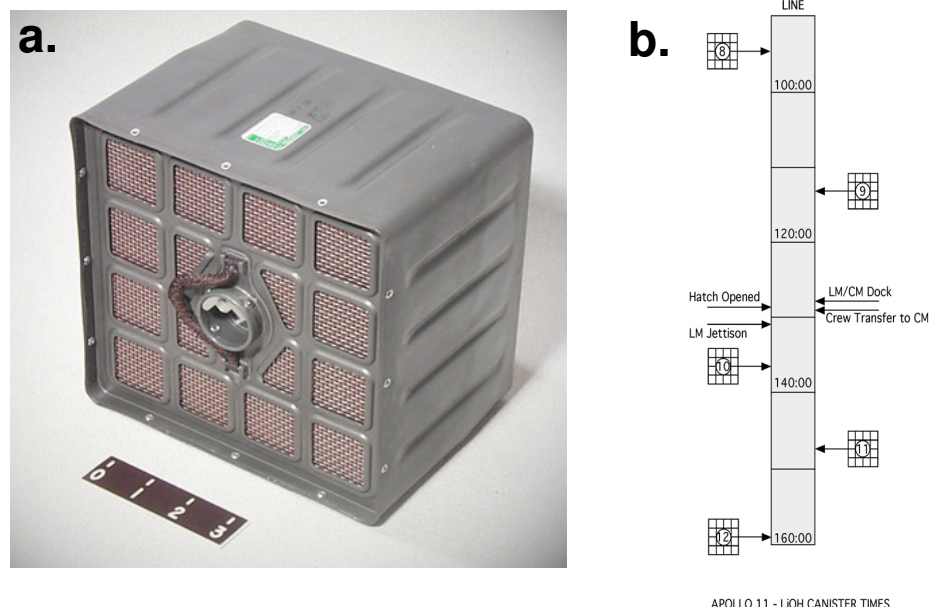
Figure 1. (a) Intake side of an Apollo lithium hydroxide (LiOH) canister. The Nomex filter lies immediately behind the wire grill that protects the air intake. (b) Portion of the Apollo 11 mission timeline showing Mission Elapsed Time (MET) at which LiOH canisters were replaced.

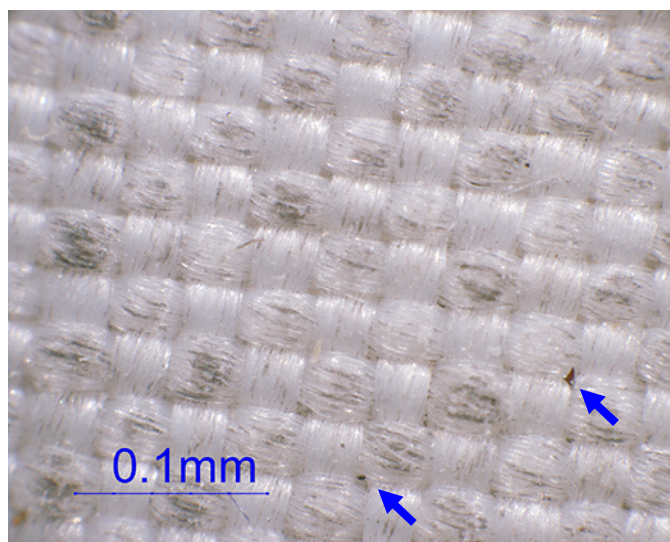
Figure 2. Light-optical stereomicroscope image showing typical resolving power for imaging of Apollo spacesuit T-164 Teflon outer fabric. Arrows show dark particles that are probably lunar soil grains.

In the current study, optical microscopy performed with binocular stereomicroscopes was a key tool, particularly for examining the surfaces of larger parts and assemblies. The use of stereomicroscopes, as opposed to higher magnification compound microscopes, was necessitated by the size and bulk of most objects investigated, and by restrictions on extracting physical samples that would fit under the shorter working distance of a compound microscope. Stereomicroscopy with digital microphotography was performed both at the Smithsonian Institution Museum Conservation Institute (MCI) using a Wild Company Model 5a stereomicroscope and at NASA JSC using Nikon corporation's model SMZ 1500 stereomicroscope. The MCI stereomicroscope was used principally for examination of the outer surface of the Apollo 17 spacesuit ITMG surface, and was fitted on a larger arm mobile support for this purpose. Figure 2 shows a typical highest-magnification digital image of a swatch of the ITMG outermost T-164 Teflon fabric containing areas of lunar soil contamination. As Figure 2 shows, under these imaging conditions it is generally possible to resolve particles 5-10 µm in diameter as long as they are significantly darker than the background fabric.

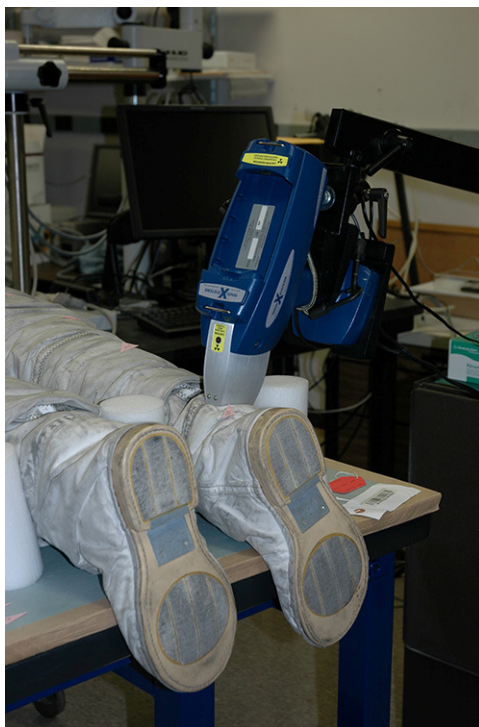
Figure 3. Innov-X Systems portable energy-dispersive X-ray fluorescence (ED-XRF) spectrometer (blue unit) held in positioning tripod for chemical analysis of outer fabric of Apollo 17 spacesuit..

At the Smithsonian Museum Conservation Institute, a portable energy-dispersive X-ray fluorescence (ED-XRF) spectrometer was evaluated as a means to measure surface-correlated variations in the chemical composition of the outer fabric of the Apollo 17 LMP ITMG and lunar boot. The goal was to determine if chemical compositions measured by ED-XRF spectroscopy could be tied to levels of lunar soil contamination. The instrument used in this analysis was an Innov-X Systems® Alpha Series™ (Innov-X Systems, Inc.) model XT-440 handheld energy dispersive X-ray fluorescence spectrometer (Fig. 3). The spectrometer generates a primary 15 or 35 keV X-ray beam that excites secondary X-rays from chemical elements of interest in the analyzed target material. Analytical sensitivity of the Innov-X Systems ED-XRF is negligible for elements with atomic numbers lower than 14 (elements P and below), and therefore the major lunar soil elements Mg, Al, and Si could not be detected. However, through the use of specific

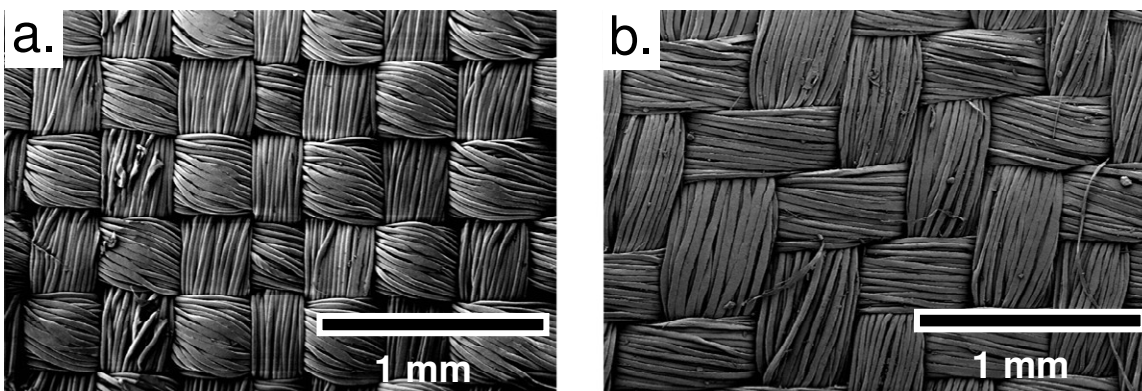
Figure 4. SEM secondary electron images of outermost T-164 Teflon fabric showing examples of both plain weave (a) and twill or diagonal weave varieties (b).

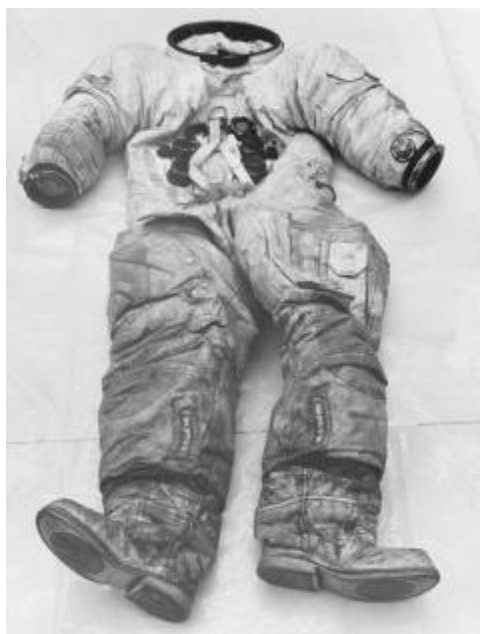
Figure 5. Integrated thermal micrometeorite garment (ITMG) from model A7L spacesuit worn on the lunar surface by Apollo 12 LMP Alan Bean. Image originally appeared in NASA Technical Report TR 169-001 prepared at the White Sands Test Facility.

Of all of the spacesuits worn on the Moon, only the spacesuit worn by the Apollo 12 LMP Alan Bean was permanently disassembled for the purpose of post-flight analysis. This analysis was conducted at the Test Operations Office at NASA's White Sands Test Facility (WSTF) shortly after the flight as documented in NASA Technical Reports Nos. TR-169-001 and TR-169-003 (Smith, 1970a, b). An image of the ITMG portion of the spacesuit taken as part of the White Sands analysis is shown in Figure 5.

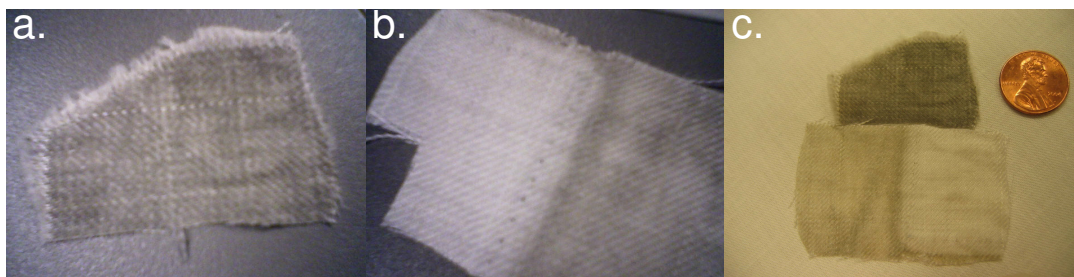
Figure 6. Samples of outer fabric from Apollo 12 LMP spacesuit. (a) Outer surface of T-164 Teflon outer abrasion fabric from left knee, (b) T-164 Teflon fabric swatch from left shoulder; lighter area was covered under U.S. flag patch. (c) Comparative size of swatches shown in (a) and (b).

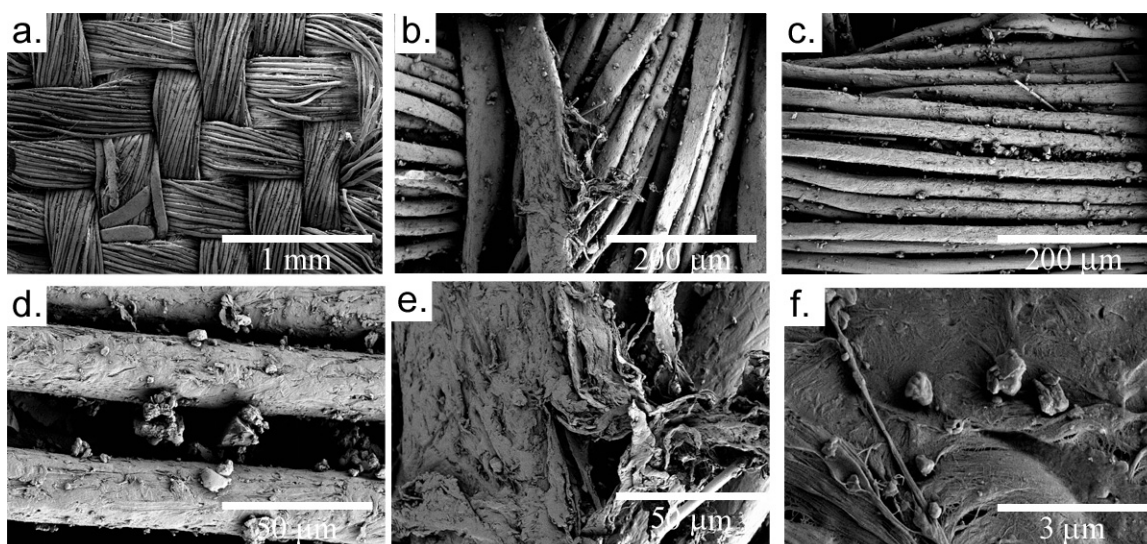
Figure 7. SEM secondary electron images of T-164 Teflon from left knee area of Apollo 12 LMP ITMG.

A series of SEM secondary electron images of the T-164 Teflon fabric from the left knee area are shown in Figure 7. Note that the fabric has a twill or diagonal-type weave pattern that is distinct from the plain weave that is more prevalent on the outer fabrics used on later Apollo spacesuits. In general, twill weaves are less durable than plain weave fabrics. In lower magnification images (Fig. 7), the fabric fiber bundles appear to be relatively intact. However, at higher magnifications (Fig. 7), lunar soil particles are

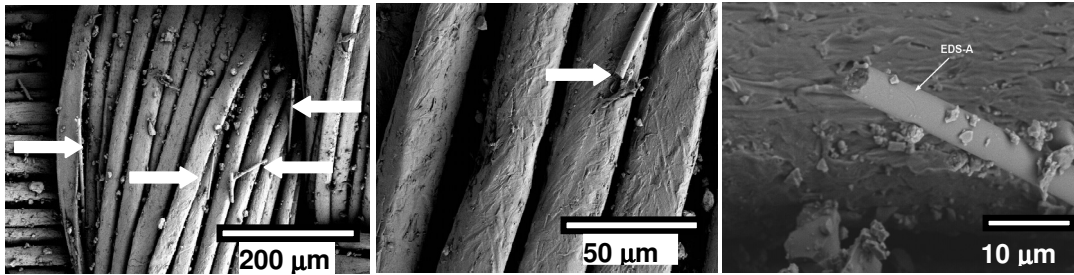
Figure 8. Secondary electron SEM images of Apollo 12 LMP ITMG outermost T-164 Teflon fabric showing fiberglass particles (arrows).

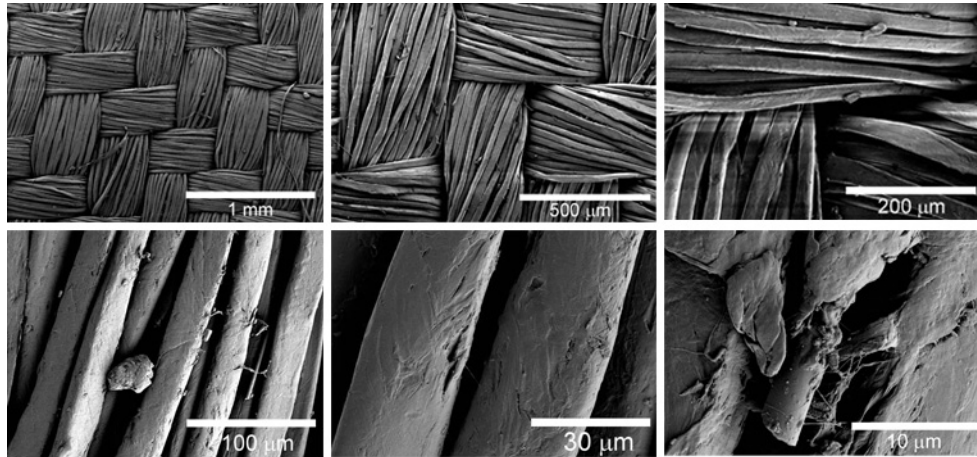
Figure 9. Secondary electron SEM images of outermost T-164 Teflon fabric from unexposed area on left shoulder on Apollo 12 ITMG that was covered by a flag patch.

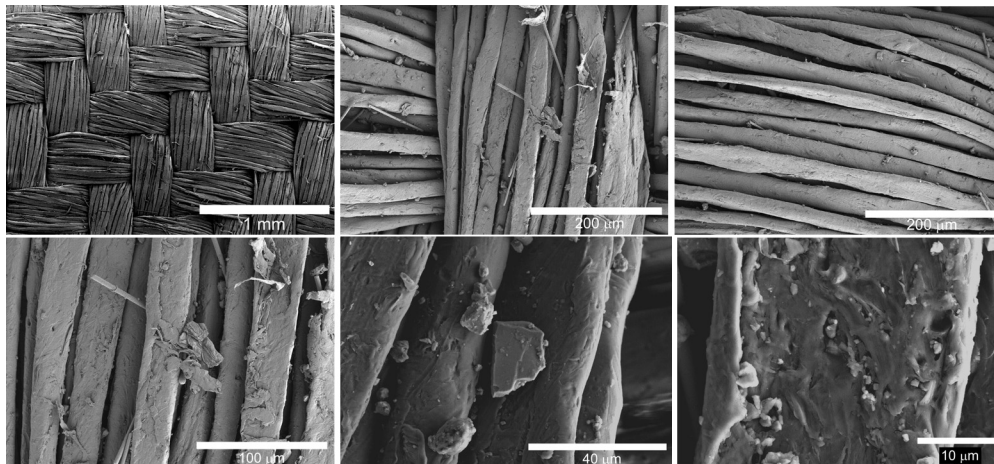
Figure 10. Secondary electron SEM images of outermost Apollo 12 ITMG T-164 Teflon fabric from exposed area on left shoulder adjacent to area covered by a flag patch.

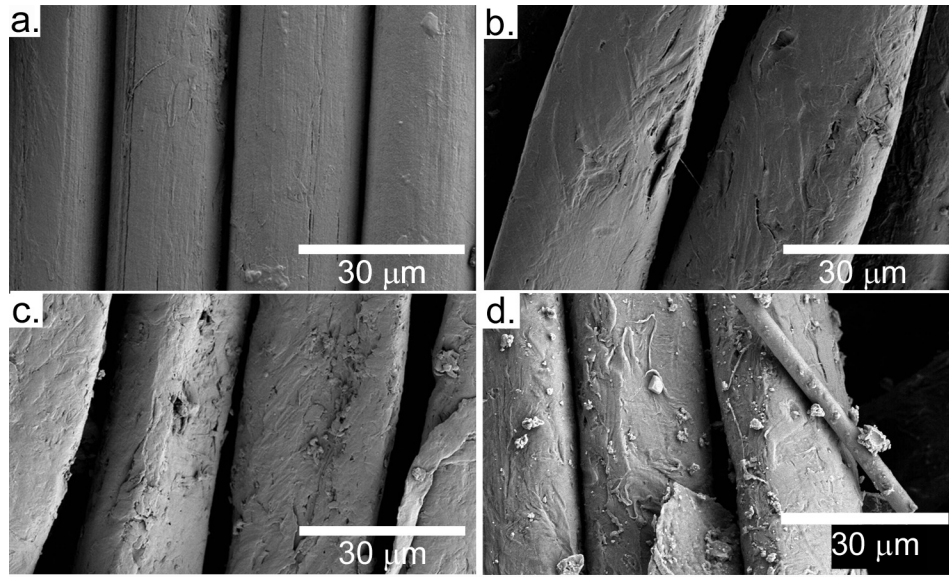
Figure 11. Secondary electron SEM images showing progressive fabric wear and damage of T-164 Teflon fabric from Apollo 12 ITMG. (a) Unused Apollo-era T-164 Teflon fabric. (b) Unexposed T-164 Teflon fabric from under flag patch. (c) Exposed shoulder area next to flag patch. (d) Left knee area with particulates and glass fiber.

A summary of the representative levels of wear and abrasion observed for the fibers comprising the three fabric areas studied is shown in Figure 11. The ability of lunar soil to produce these and the other observed wear features was studied in a controlled abrasion test. The objective was to verify that lunar soil interaction, as opposed to wear caused by contact with hard surfaces (e.g., LM ladder, LM hatch and

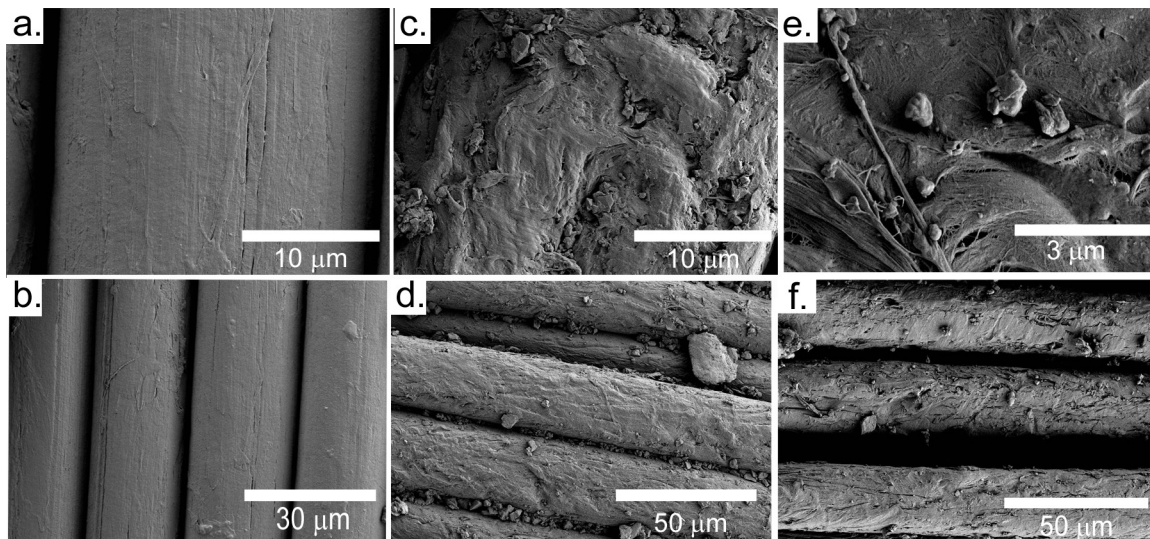
Figure 12. Secondary electron SEM images of beta cloth artificial wear test. (a) High and (b) low magnification images of pristine, unworn beta cloth. (c) High and low (d) magnification images of beta cloth artificially abraded with lunar simulant. (e) High and low (f) images of betacloth on knee area of Apollo 12 spacesuit.

entryway) was able to cause the effects observed. Grains of a lunar soil simulant (JSC1AF; Hill et al., 2007) were heavily sprinkled onto pristine, non-flight, swatches of Apollo-era beta cloth and ground into the fabric with a mortar and pestle. The fabric was then cleaned with water and a surfactant and allowed to dry. SEM examination showed features very similar to those observed on the left knee fabric (Fig. 12). Thus, while wear due to hard surface interactions remains an alternative source of the fabric abrasion effects observed, it appears that lunar soil is a possible and quite likely cause.

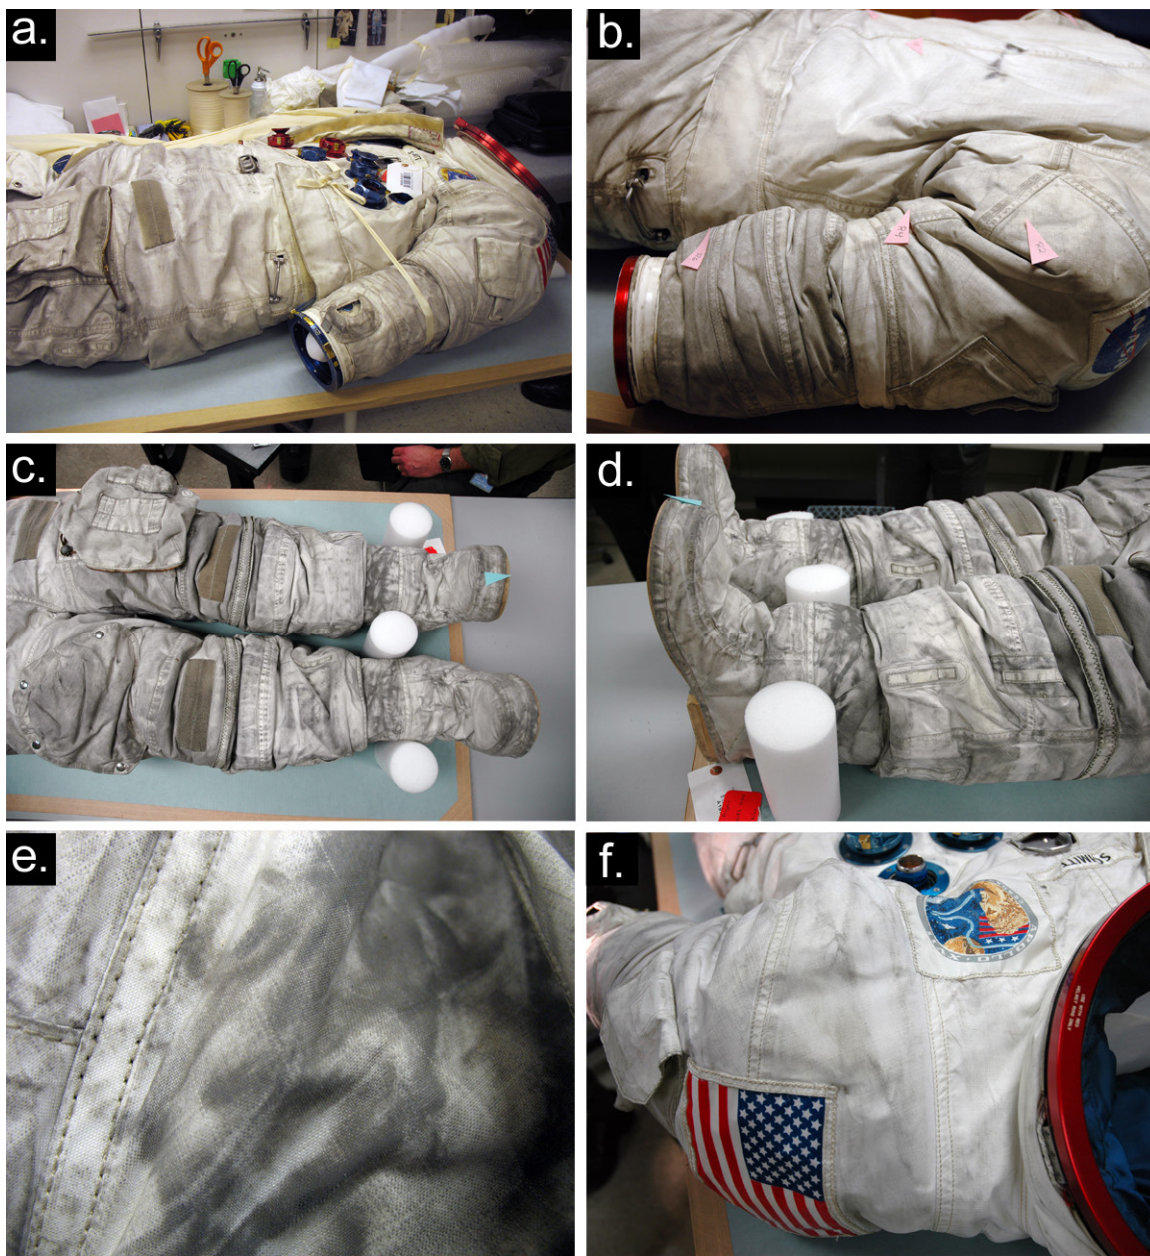
Figure 13. Views of Apollo 17 LMP A7LB spacesuit. a) Upper torso, b) upper back, c) front of legs, d) integrated pressure boots, e) close up of heavily soiled area on pressure boot, seam is approximately 1 cm wide, f) left shoulder

Initial visual inspection and photodocumentation of the Apollo 17 LMP ITMG revealed the outer ITMG fabric to have a variably “dirty” appearance as indicated by different levels of gray discoloration of the fabric. Figure 13 shows various views of the Apollo 17 suit, including one image of a highly discolored/soiled area on the lower leg. In general, the most discolored areas of the ITMG fabric are on the

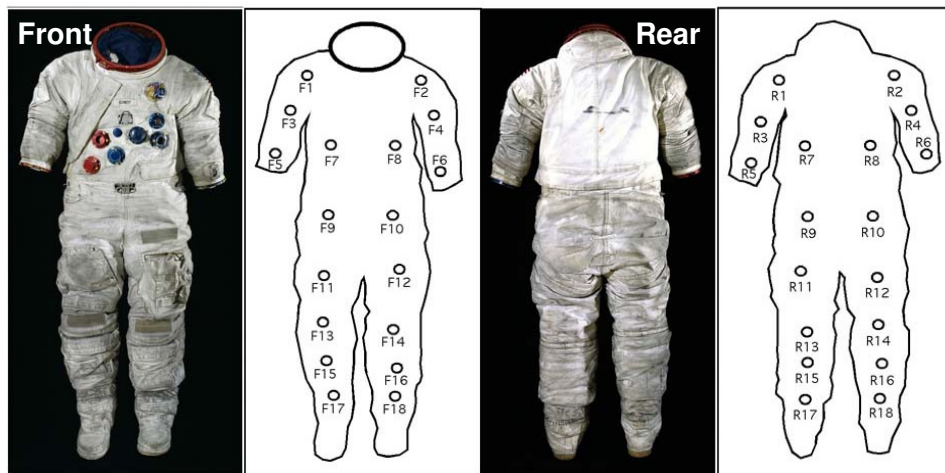
Figure 14. Particle sampling locations on the outer fabric of the Apollo 17 LMP ITMG.

Using the tape extraction technique described above, particle samples were obtained from the locations on the Apollo 17 ITMG outer fabric shown in Figure 14. The adhesive tape strips were prepared for SEM examination by affixing their non-adhesive sides to conductive carbon tape, and applying a thin coat of evaporated carbon to the top adhesive side containing the particles. SEM examination of the adhesive surfaces was performed using both secondary electron imaging (SEI), and backscattered electron imaging (BSE), as well as EDS analyses. The concentration of extracted particles on the tape surface was generally inhomogeneous on the 100-500 μm scale. In some cases the extracted particles formed a pattern

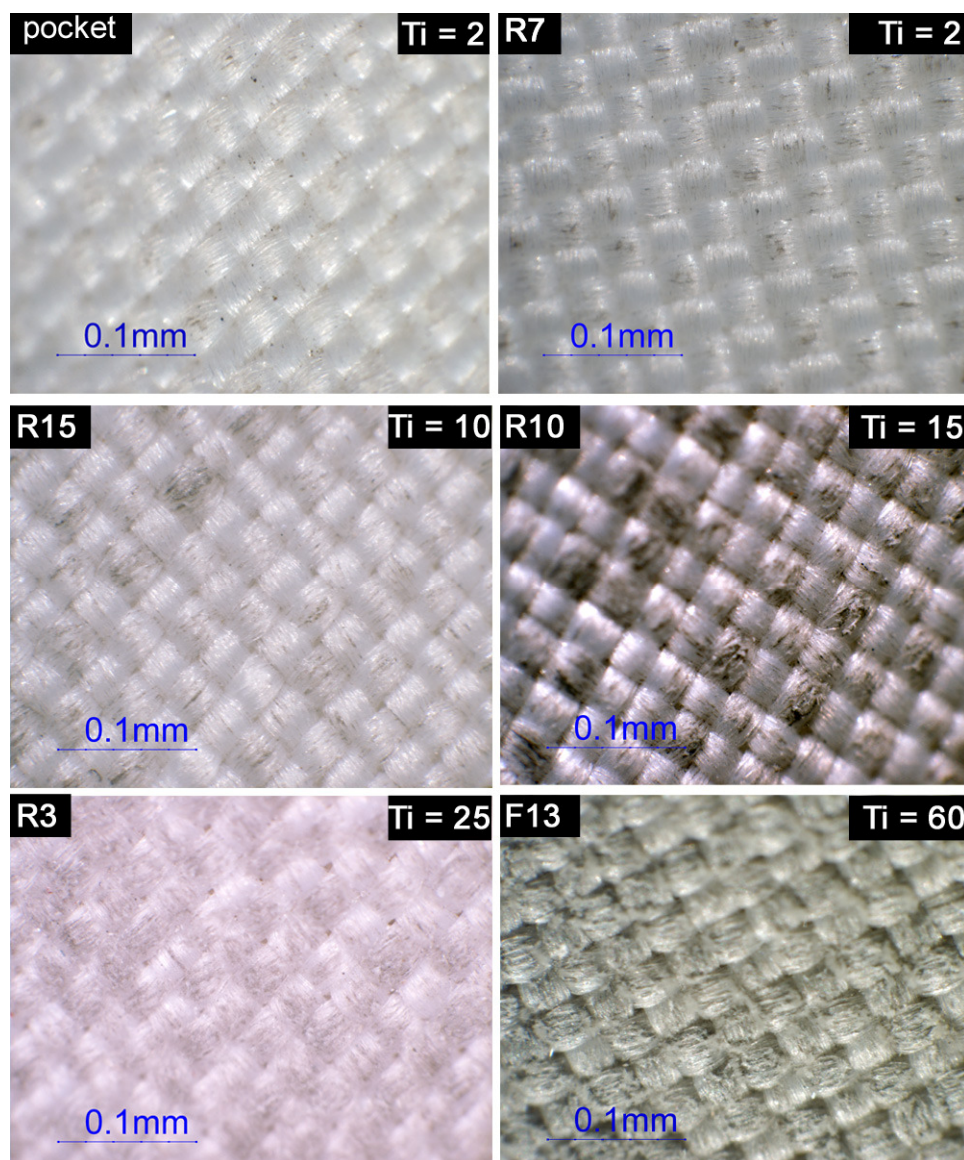
Figure 15. Stereomicroscope images of analyzed areas of T-164 teflon fabric on Apollo 17 ITMG. Number-letter designations correspond to spacesuit locations shown in Fig. 14.. The relative Ti concentration measured at each image location are in units of $\text{ppm} \times 10^2$. Image labeled “pocket” is minimally-contaminated area inside spacesuit’s front pocket. Location F13 had the highest relative Ti concentration of all analysis locations.

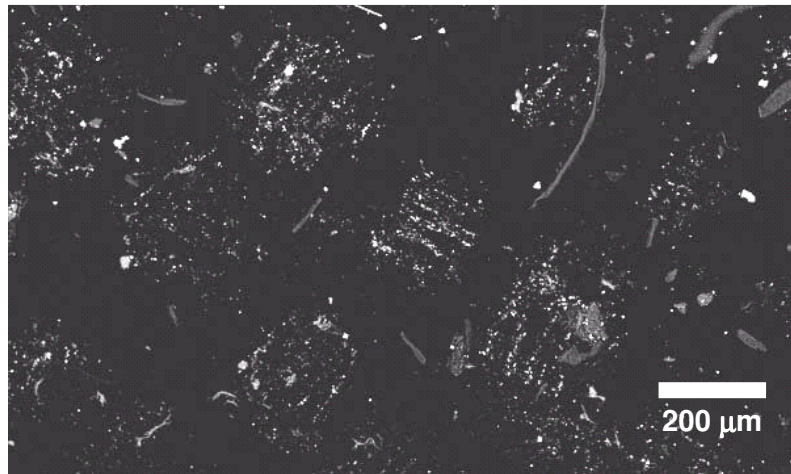
Figure 16. Low-magnification SEM backscattered electron image of surface of adhesive tape used to sample particles from the outer T-164 Teflon fabric of the Apollo 17 LMP ITMG. Particle distribution shows imprint of spacesuit fabric weave.

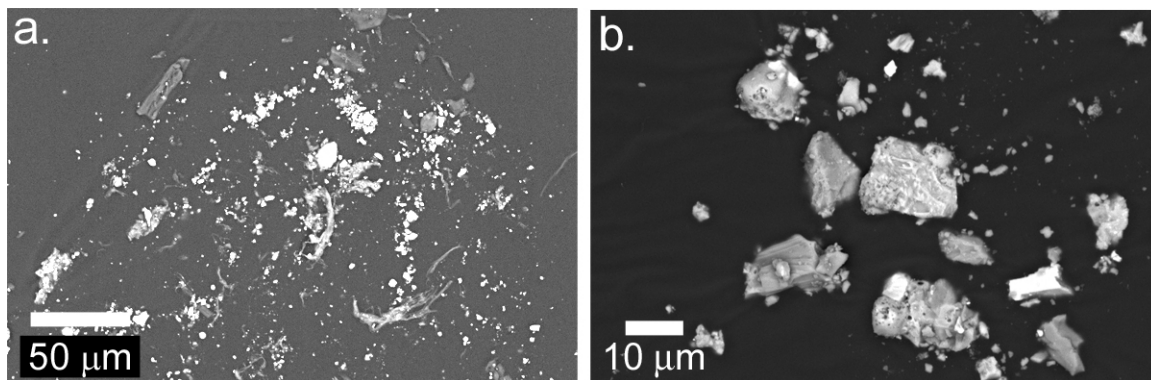
Figure 17. SEM back-scatter electron images of adhesive tape surfaces with typical particles concentrations at low (a) and high (b) magnifications.

On each strip of tape, a number of areas were selected for detailed SEM imaging. Figure 17 shows examples of areas with typical grain concentrations at different magnifications. Within a given field of view, grains were identified and categorized based on grain morphology combined with data from EDS chemical analyses. This approach was effective in identifying grains larger than $1\text{-}2\text{ }\mu\text{m}$ in size, but for smaller grains, the reduction in the X-ray excitation volume yielded insufficient X-ray counts to get reliable EDS data. For this reason, the particle type data reported here are only for grains larger than $1\text{-}2\text{ }\mu\text{m}$, with smaller particles remaining unidentified and uncounted.

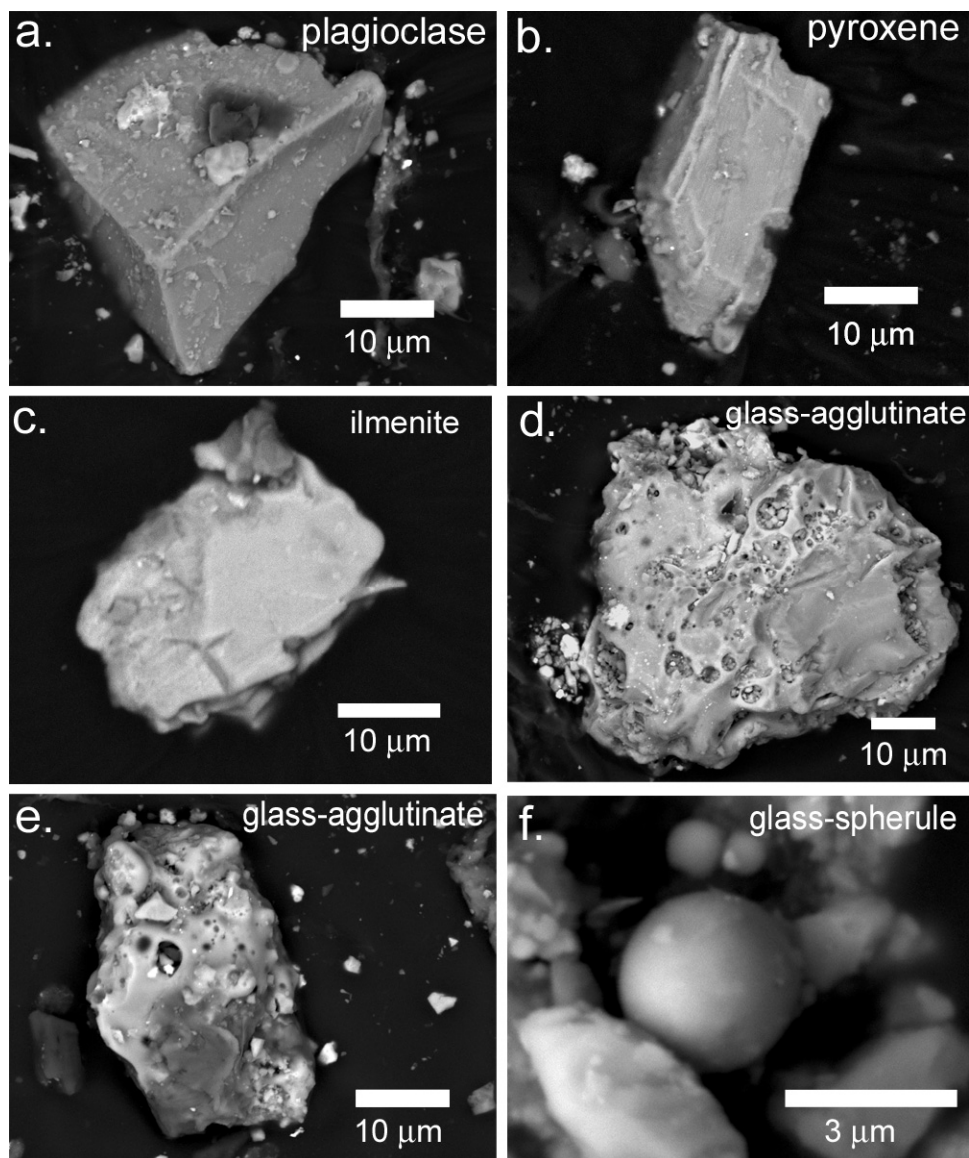
Figure 18. SEM backscattered electron images of particles of various mineralogical types from the surface of the Apollo 17 LMP ITMG T-164 Teflon fabric. (a) plagioclase feldspar, b) pyroxene, c) ilmenite, d) agglutinitic glass, e) agglutinitic glass, f) impact glass spherules.

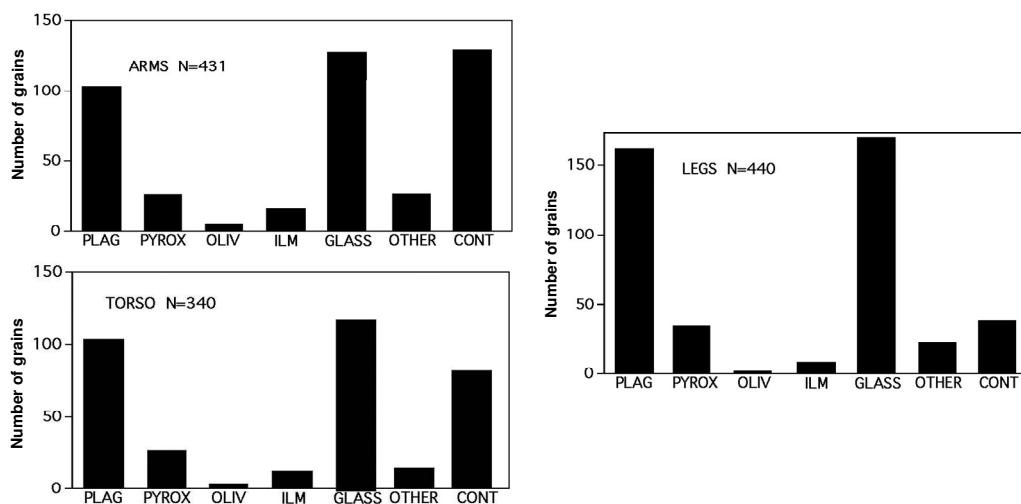
Figure 19. Relative counts for particles of different types sampled from three areas of the Apollo 17 LMP ITMG surface fabric.

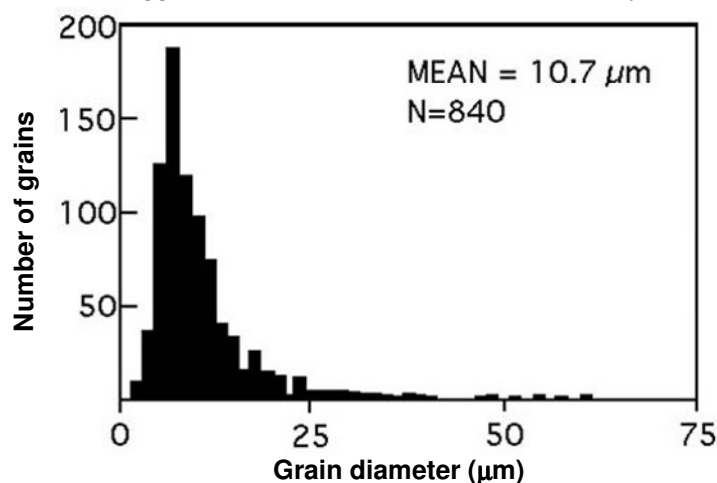
Figure 21. Size distribution of lunar grains obtained from outer surface of Apollo 17 ITMG by tape sampling.

population of 846 confirmed lunar grains has a mean grain size, based on diameter, of 10.7 μm with a median of 8.3 μm and a mode of 5.5 μm (Fig. 21). Qualitative review of the *ImageJ* data acquired from different areas of the suit suggested the size distributions are relatively uniform across all sampled areas.

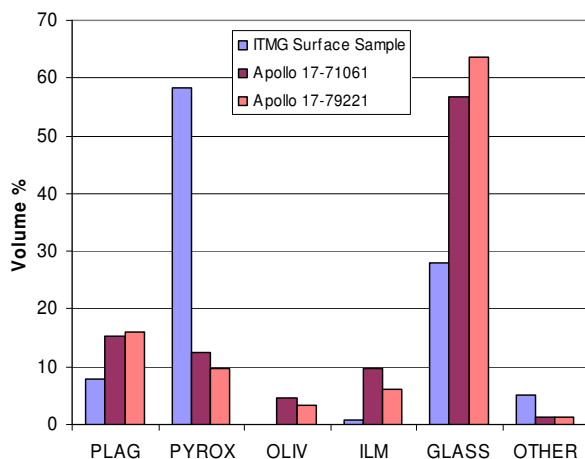
Figure 22. Modal (volume %) mineralogy of tape-extracted particle samples from Apollo 17 LMP spacesuit ITMG outer fabric compared to representative Apollo 17 soil samples from Taylor et al. (2001).

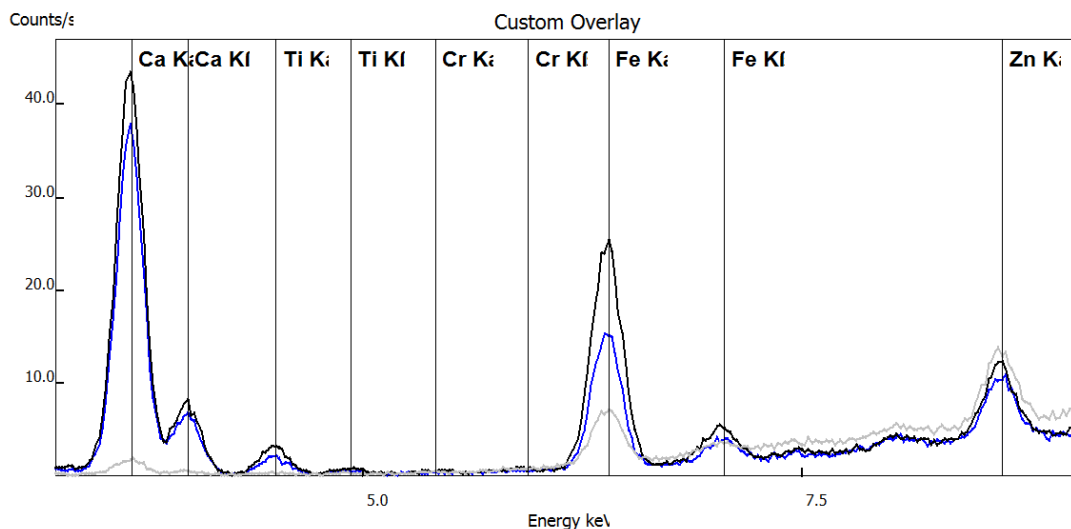
Figure 23. ED-XRF spectra of Apollo 17 LMP ITMG outer fabric showing spectra obtained from clean pocket area (blue trace), dirty area outside pocket (black trace), and spectrum of spacesuit fabric reference stack (gray trace). Vertical lines show markers for ED-XRF secondary X-ray peaks for various elements.

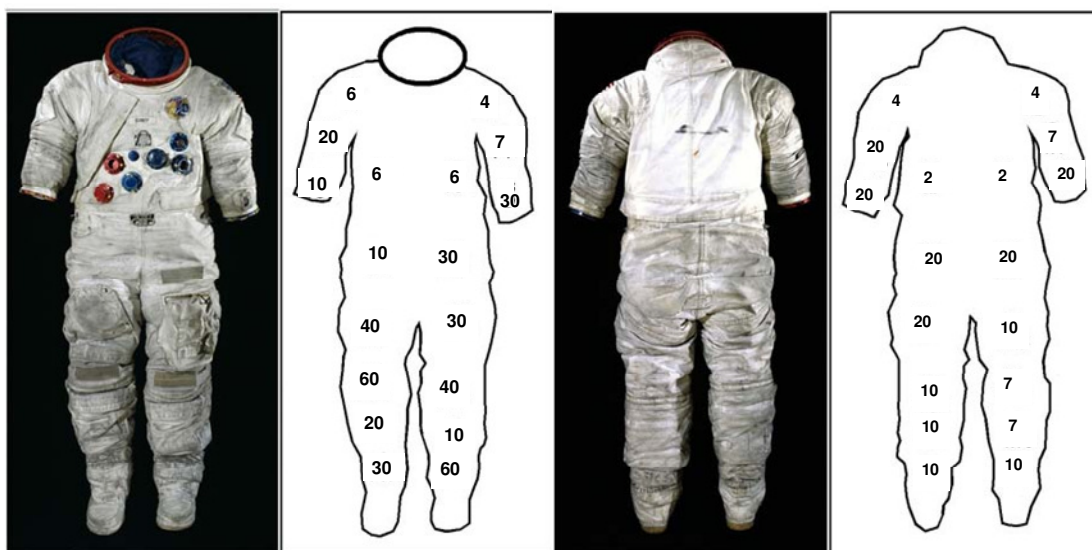
Figure 24. Concentration of Ti in units of $\text{ppm} \times 10^2$ measured by ED-XRF for tape-sampled location on front (left) and back (right) of Apollo 17 LMP ITMG (see Fig. 14).

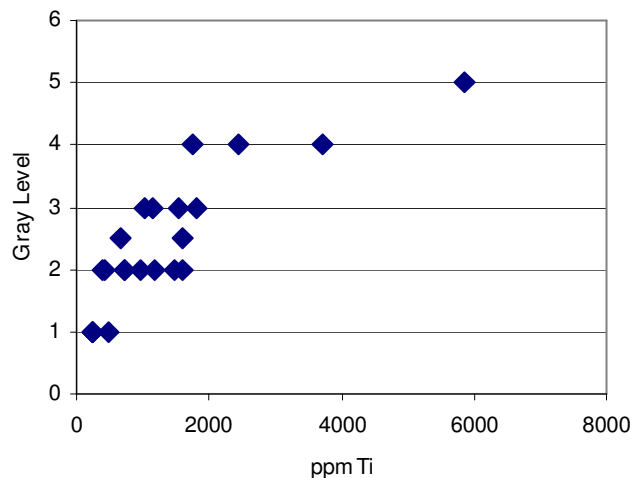
Figure 25. Visually-estimated gray level of Apollo 17 spacesuit outer fabric ED-XRF analysis locations plotted against measured Ti content in parts-per-million (ppm).

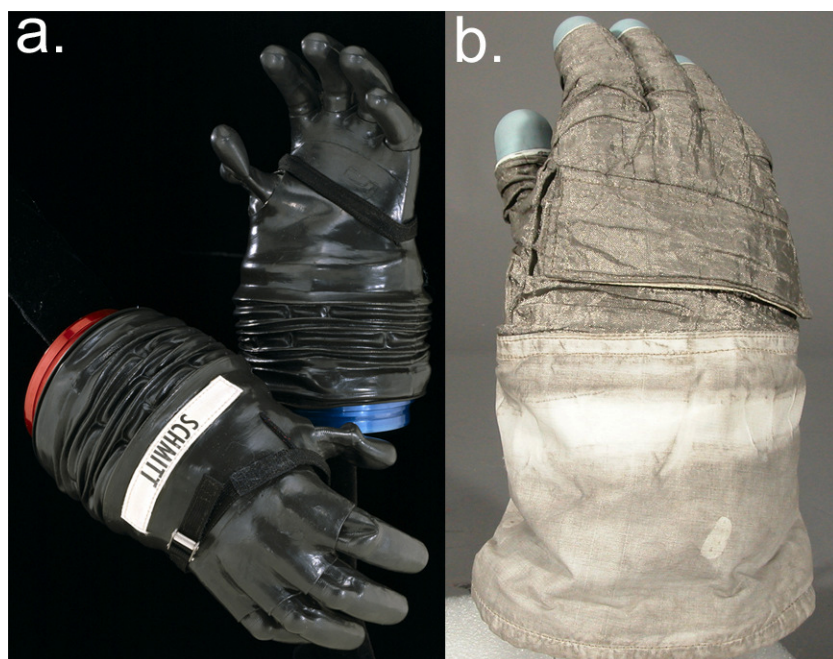
Figure 26. Examples of the two types of Apollo spacesuit pressure gloves. a) Apollo 17 LMP intravehicular (IV) pressure gloves, b) Apollo 17 LMP extravehicular (EV) pressure glove. (Official Smithsonian images used by permission).

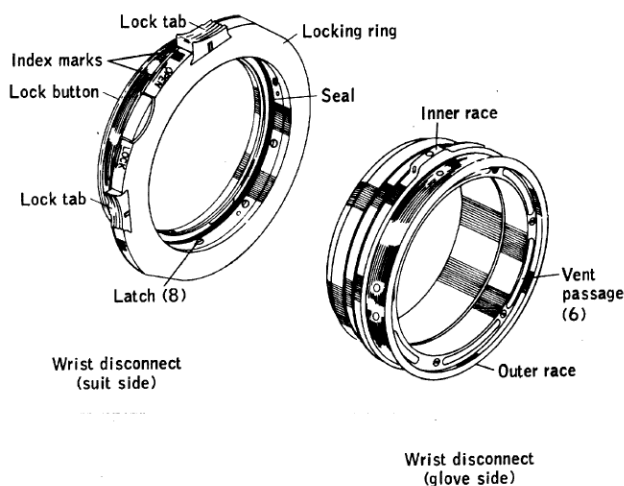
Figure 27. Apollo spacesuit pressure glove wrist disconnect assemblies

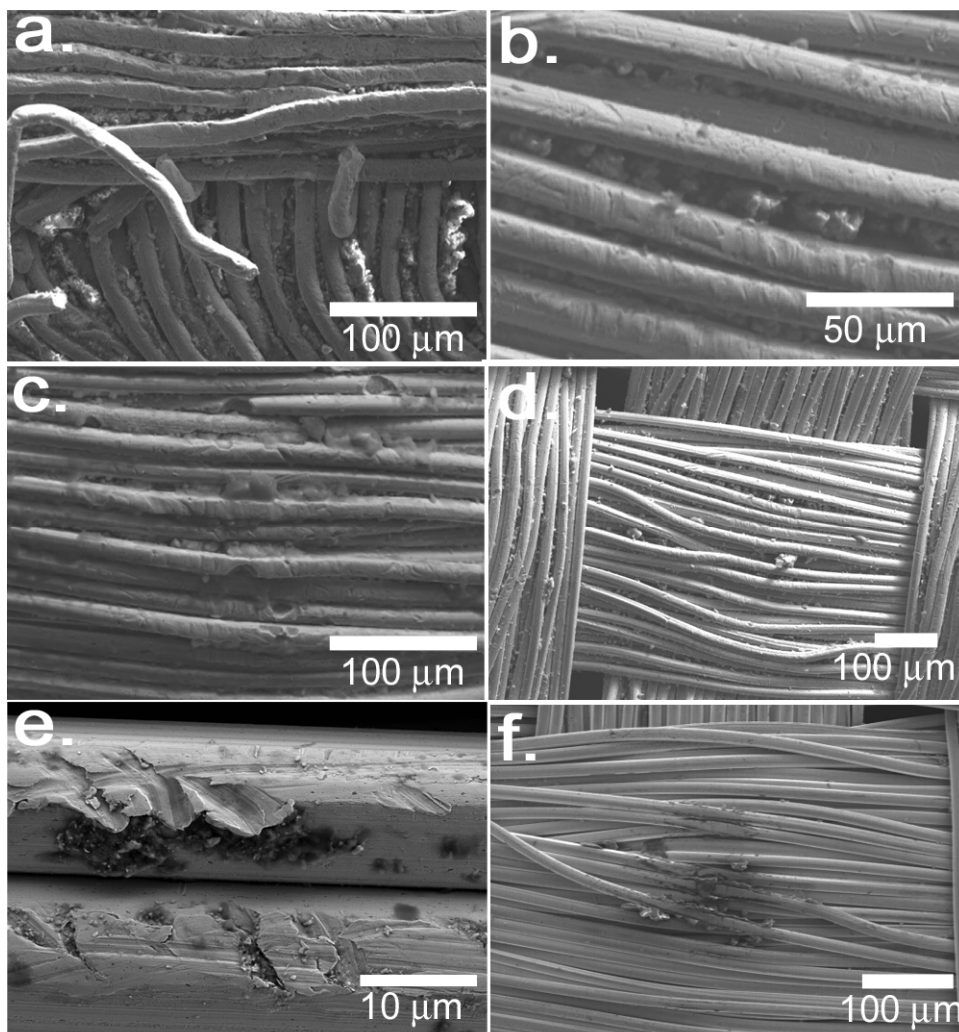
Figure 28. SEM secondary electron images of Chromel R fabric used in Apollo EV pressure glove. Images (a,b,c,d) show Chromel R fibers on backside of Apollo 17 LMP EV pressure glove. Images (e,f) show Chromel R fibers on stock piece of Chromel R fabric subjected to typical wear and contamination from normal handling in the JSC Crew and Thermal Systems division.

Key features of the glove Chromel R fabric areas imaged by SEM are shown in Figure 28. Among the observations were broken Chromel R metal threads that had been pulled out of the weave (Fig. 28a). The absence of separate thread fragments in areas associated with these broken fibers suggests either that the breakage occurred during manufacturing, or that the loose fibers, once pulled out of the weave, are easily broken by fatigue. Other features more likely to have been produced during the missions are sets of scratches and scoring perpendicular to the threads, especially on the “high points” of the weave (Fig. 28b). The consistent parallel alignment of the scratches and the relative hardness of the Chromel R metal fibers makes it more likely that these features resulted from handling or actuating high-hardness metal

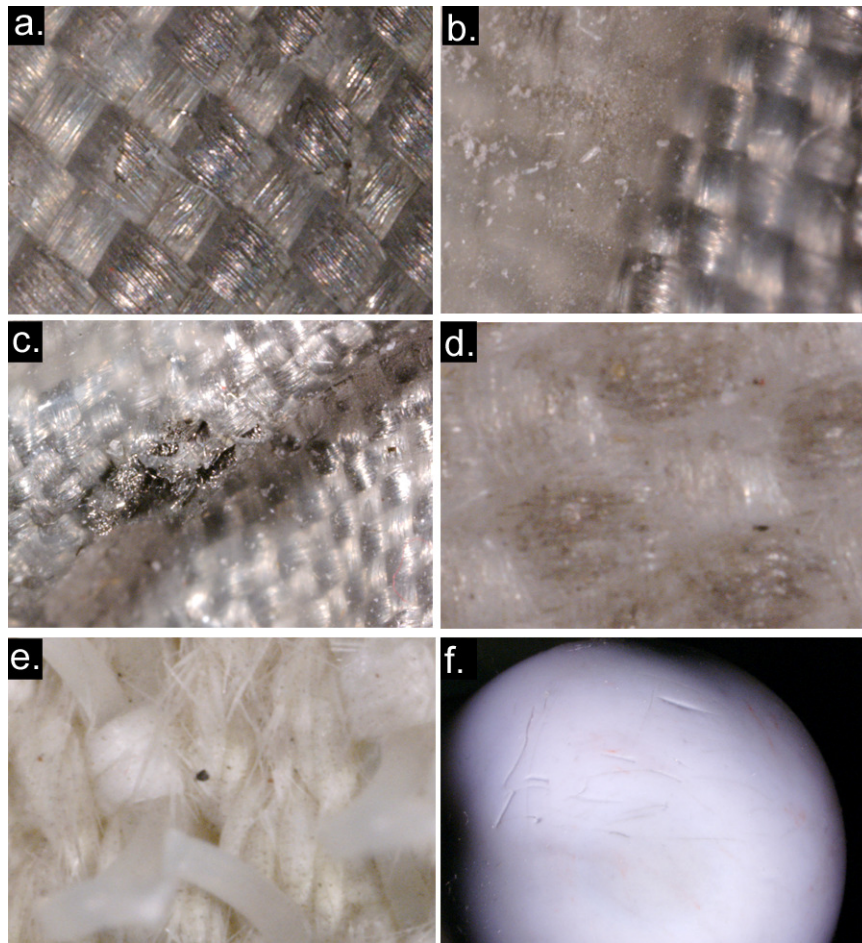
Figure 29. Optical stereomicroscope images of areas of exterior fabric on Apollo 17 LMP EV pressure glove. a) Chromel R fabric with silicone rubber coating, arrow shows areas where coating abraded away, b) silicone rubber coating on chromel R fabric with particulate contamination, c) tear in chromel R fabric, d) beta-cloth on glove gauntlet with dark particulate grain (arrow), e) velcro fabric with dark grain (arrow), f) nylon tri-cot finger tip hard shell with scratches and gouges.

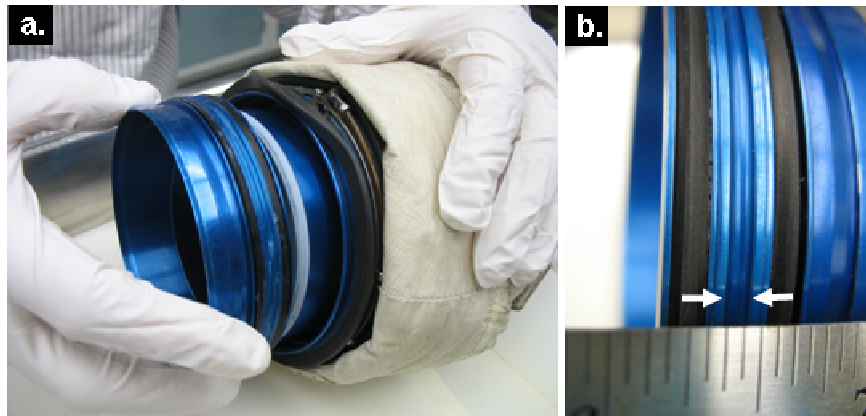
Figure 30. View of disassembly (a) and bearing surface (b) of the Apollo 16 LMP EV pressure glove wrist rotation bearing. Arrows in (b) indicate the sides of the “race” in which the ball bearings are seated. Ruler scale is calibrated in 1/16 of an inch.

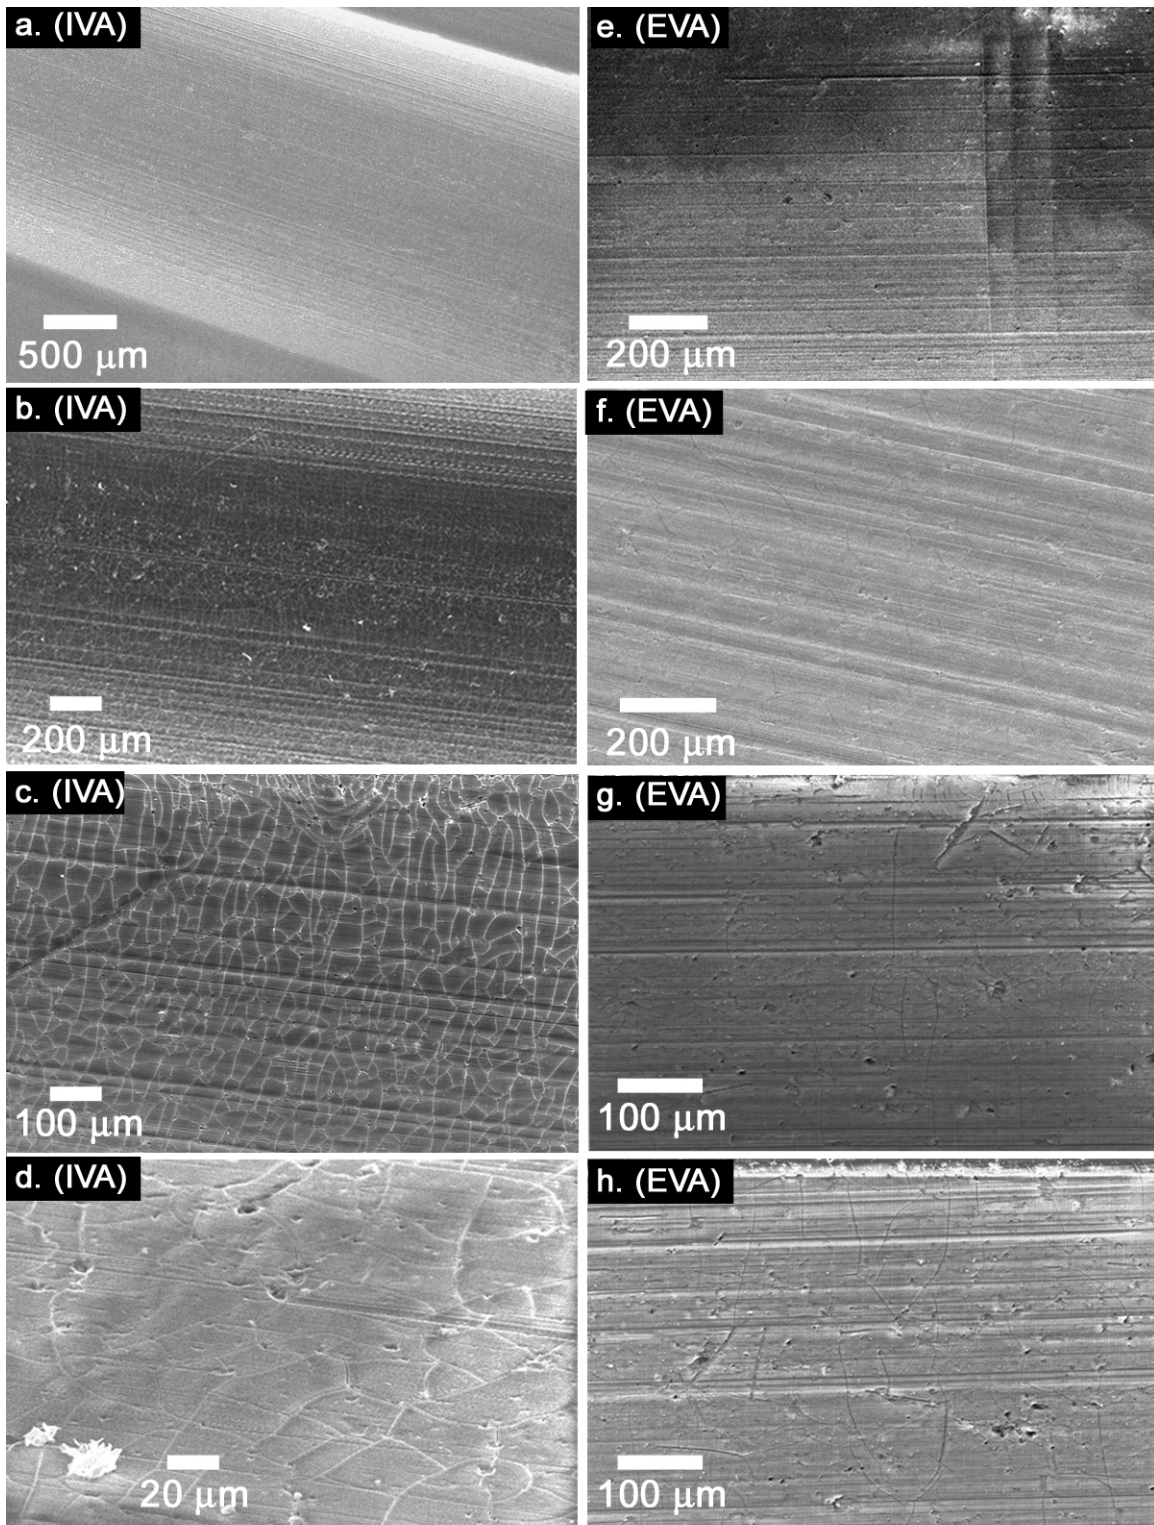
Figure 31. SEM secondary-electron images of surfaces on the bottom and sides of the ball-bearing race in the wrist-rotation bearing from the Apollo 16 LMP pressure gloves. Images a. – d. (IVA) are from the bearing race in the IV pressure glove. Images e. – h. (EVA) are from the bearing in the EV pressure glove.

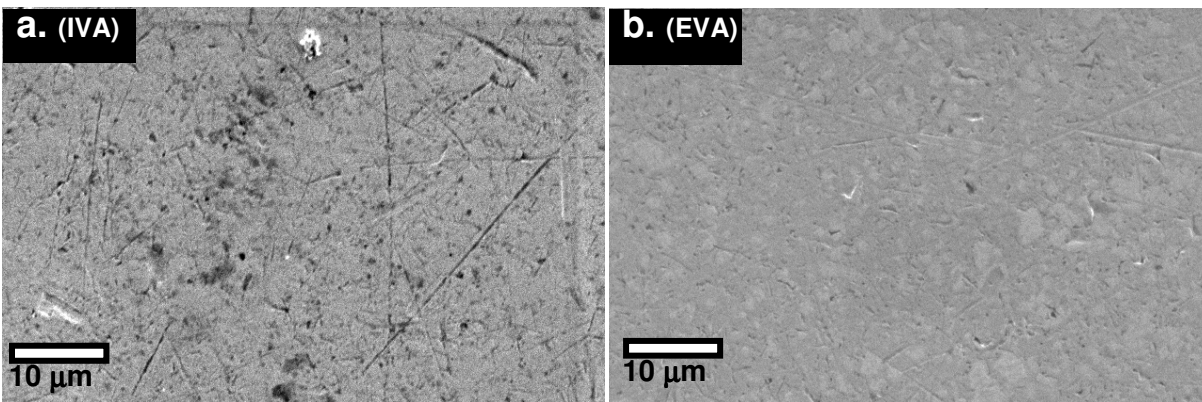
Figure 32. SEM secondary-electron images of surfaces of ball bearings from the Apollo 16 LMP IV pressure glove rotation bearing (a), and EV pressure glove rotation bearing (b).

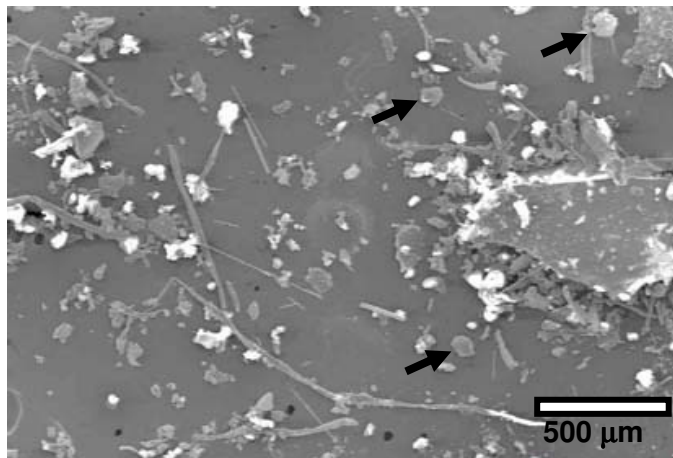
Figure 33. Secondary electron SEM image of particles rinsed from LiOH canister filter. Most particles are human dander or fiberglass but a smaller number are lunar soil particles (arrows).
